# Evaluating the cost-effectiveness of four pavement treatments

| Selecting a smart and efficient road-maintenance strategy

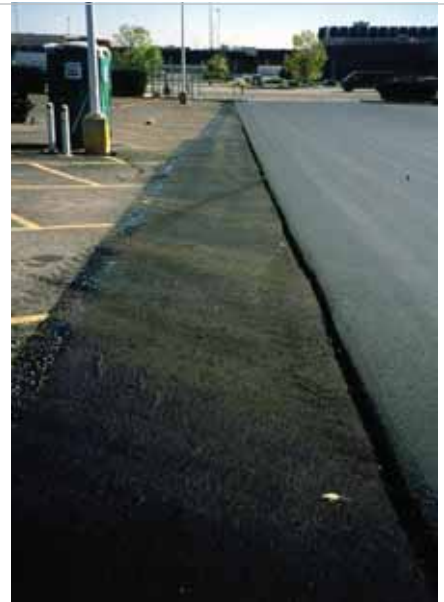
| Left to right: tack coat, paving fabric, overlay.

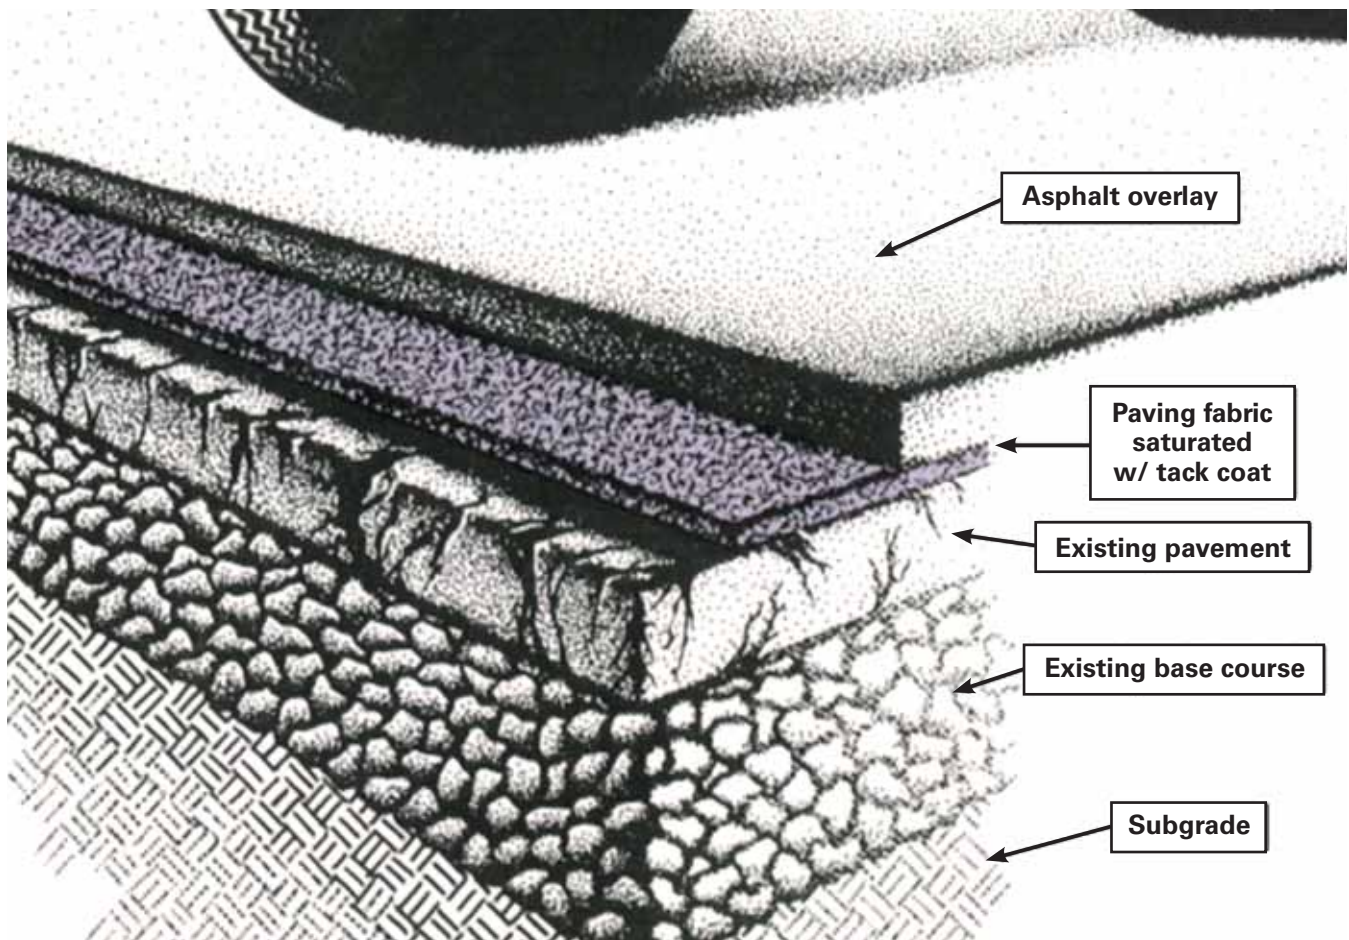
| This diagram illustrates the components of a paving fabric/overlay installation.

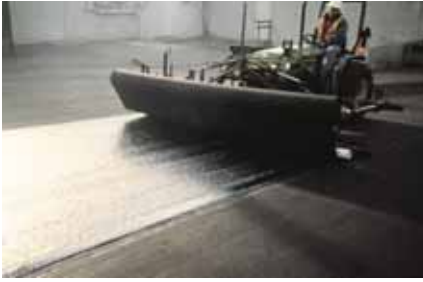
| Installation of the paving fabric over the tack coat.

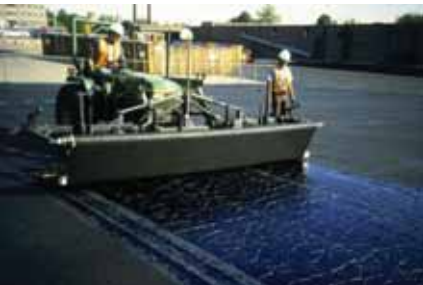
| With the tack coat already sprayed on, the paving fabric is now placed over this substantially cracked surface.

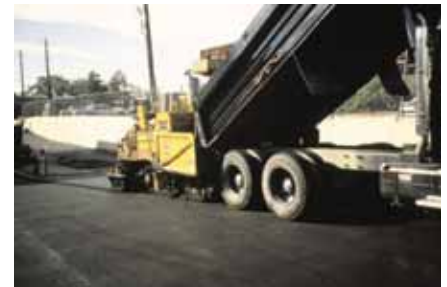
| With the paving fabric installed, an asphalt overlay is completed.

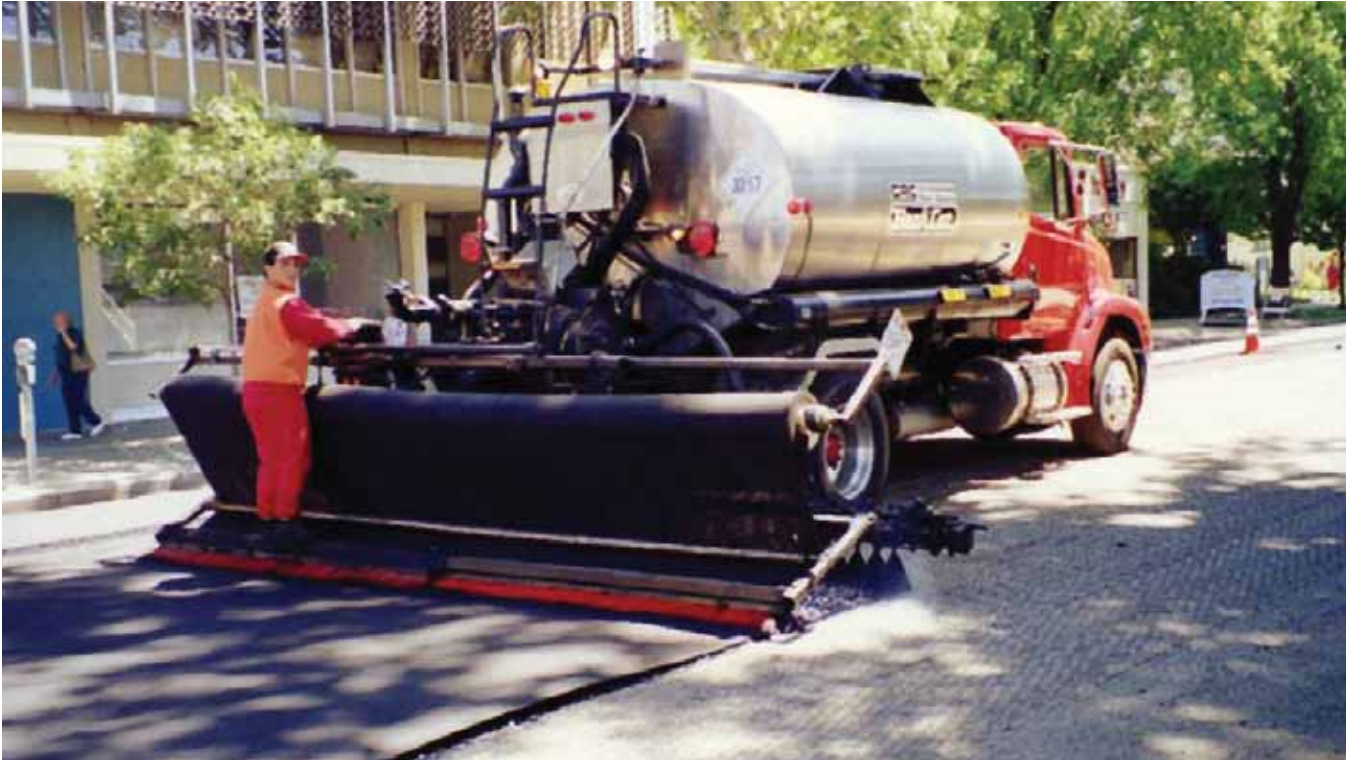
Here, a paving fabric laydown apparatus is attached to the tack coat truck, thus facilitating simultaneous tack coat spraying and paving fabric application.
