Evaluating the cost-effectiveness of four pavement treatments

| Selecting a smart and efficient road-maintenance strategy

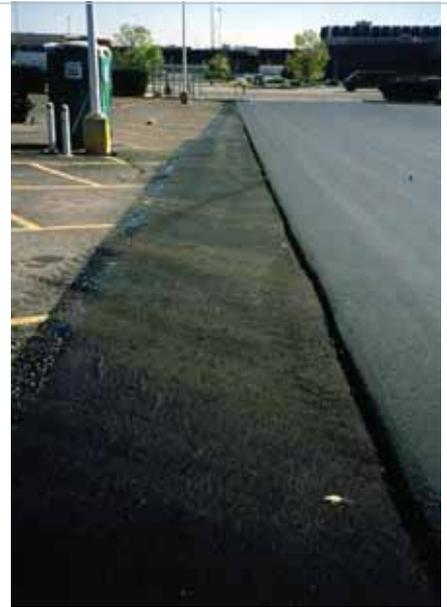
| Left to right: tack coat, paving fabric, overlay.

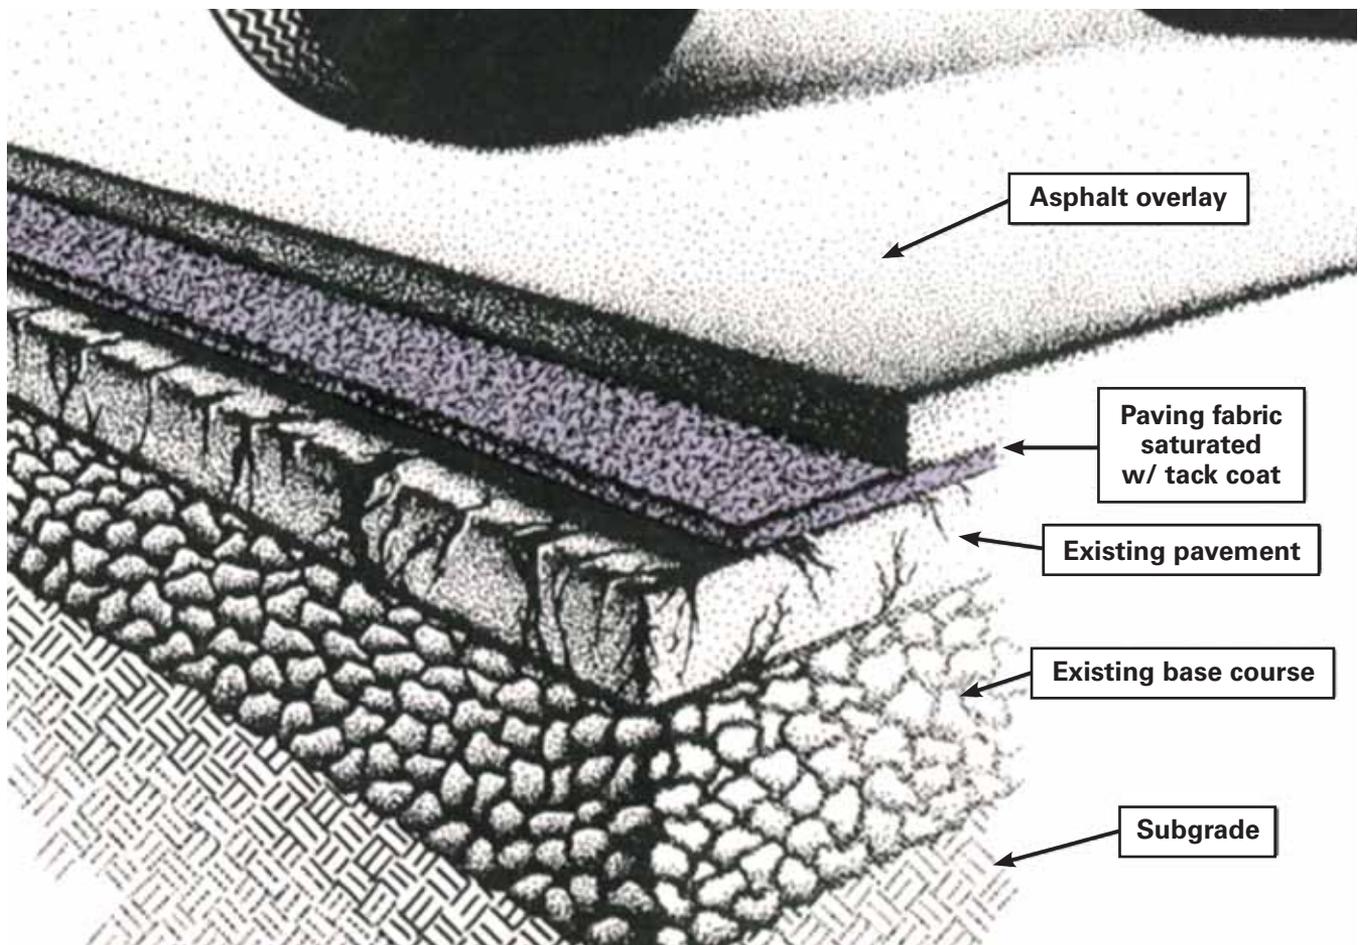
| This diagram illustrates the components of a paving fabric/overlay installation.

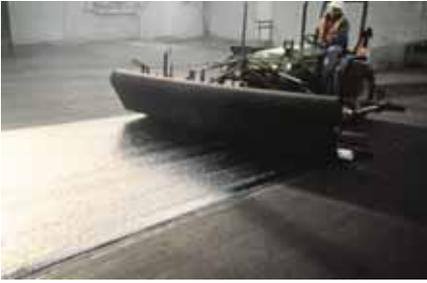
| Installation of the paving fabric over the tack coat.

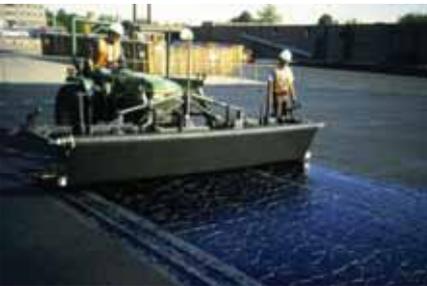
| With the tack coat already sprayed on, the paving fabric is now placed over this substantially cracked surface.

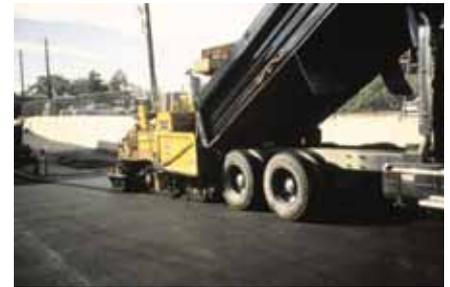
| With the paving fabric installed, an asphalt overlay is completed.

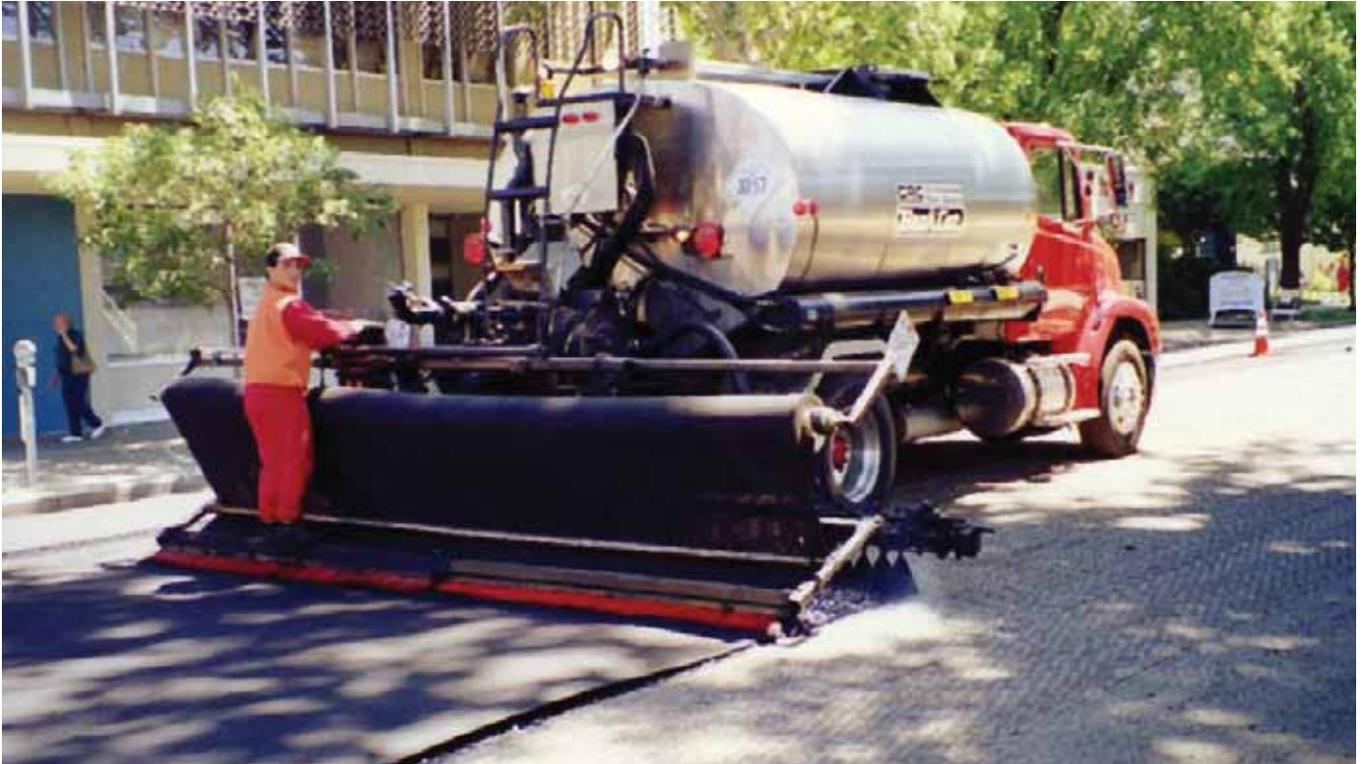
Here, a paving fabric laydown apparatus is attached to the tack coat truck, thus facilitating simultaneous tack coat spraying and paving fabric application.
