FIBERMAT MURRAY, NEW YORK

Project Profile

Groth Road

Murray, New York

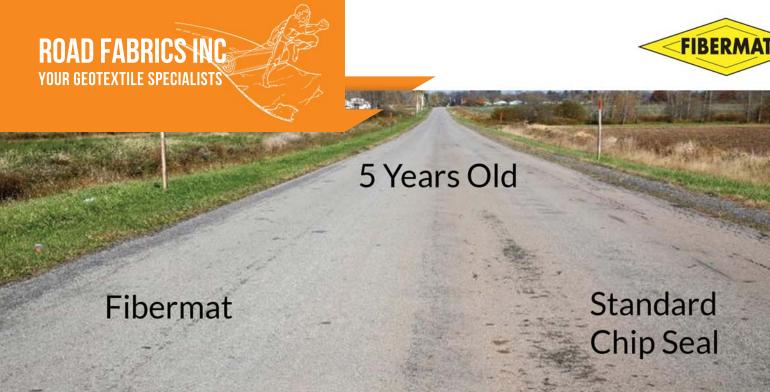
A 5-year evaluation study of the FiberMat® Type A process was performed in upstate New York. One side of the chosen road was treated with a chip seal overlay placed while the other with the FiberMat® Type A process. This road surface had many reflective cracks likely caused by years of stress due to seasonal shifting and snow plow damage.

After one year of wear and tear on this test road, longitudinal reflective crack had started to reappear on the regular chip seal side while no cracks had appeared on the FiberMat® Type A reinforced membrane side of the road. Note that cracking was present on both sides of the road prior to application.

The following year, longitudinal reflective cracking and snowplow damage were evident on the chip seal side while the FiberMat® Type A side was still in very good condition.

On the third year of evaluation, further evidence of snowplow damage was noted on the chip seal side while only slight damage started to occur on the fiber-reinforced membrane side; all the while the FiberMat® Type A membrane itself was still intact.

By year four, the chip seal side showed significant deterioration. It was now becoming a candidate for total rehabilitation. The FiberMat® Type A side, after 4 years of use, only just started to show some minor damage.

Year five showed that the original chip seal side had fully deteriorated, with aggregate loss and raveling along with all afore mentioned distresses; a candidate now for full depth reclamation. However, the condition of the FiberMat® Type A side altered minimally from the previous year. It was still years away from requiring any repairs or rehabilitation.
