Project Profile

Project Name:
Illinois Tollway I-88

J-BAND® ILLINOIS TOLLWAY I-88

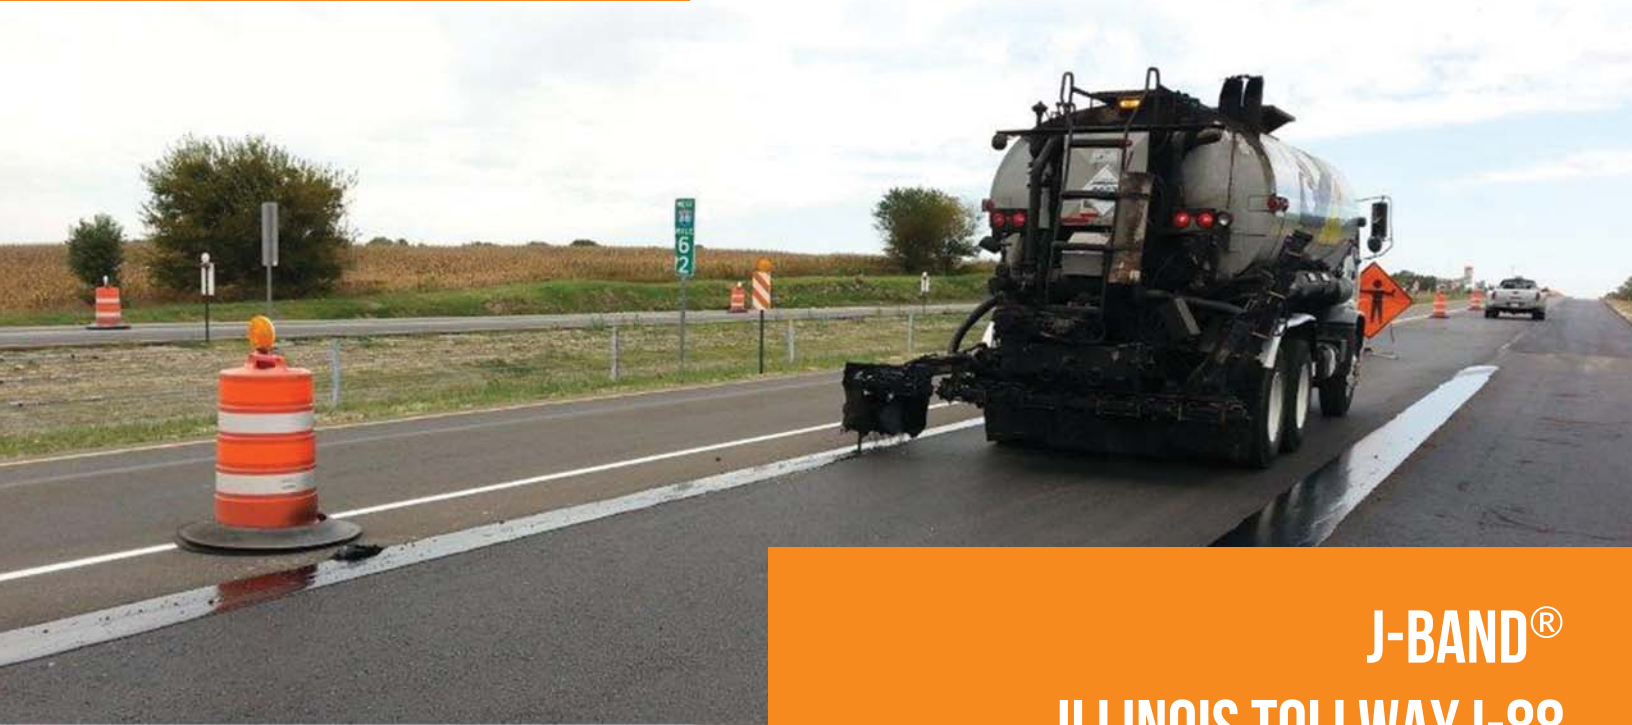
J-Band® is placed in the form of a heavy membrane under the intended area for an overlay construction joint, 18" wide and with thickness up to 5/32". J-Band® then migrates into the high air voids in the HMA overlay in the area of the longitudinal construction joint and reduces voids to more typical HMA range.
